Wind Mitigation Report

2375 Harmony Ln

Naples

Uniform Mitigation Verification Inspection Form

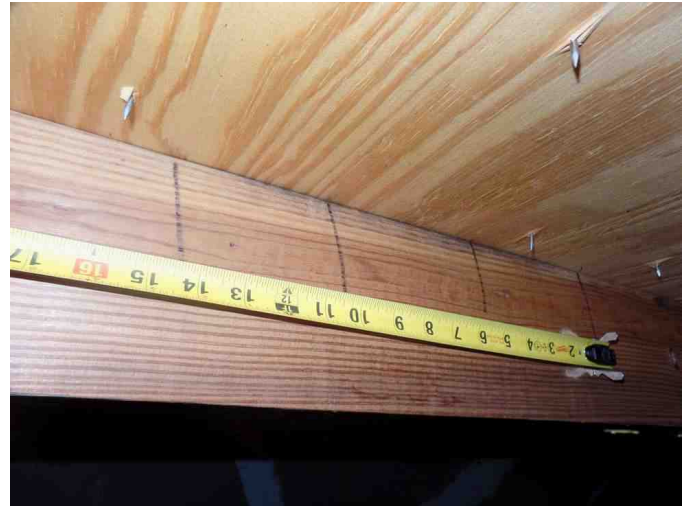
- C. Plywood/OSB roof sheathing with a minimum thickness of 7/16" inch attached to the roof truss/rafter (spaced a maximum of 24" inches o.c.) by 8d common nails spaced a maximum of 6" inches in the field. -OR- Dimensional lumber/Tongue & Groove decking with a minimum of 2 nails per board (or 1 nail per board if each board is equal to or less than 6 inches in width). -OR- Any system of screws, nails, adhesives, other deck fastening system or truss/rafter spacing that is shown to have an equivalent

8D Nails Every 6 Inches

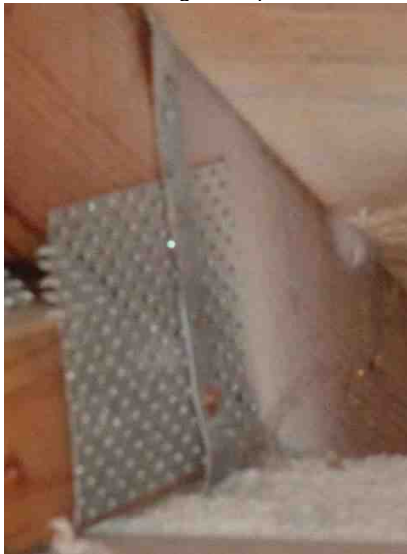
Single Wrap

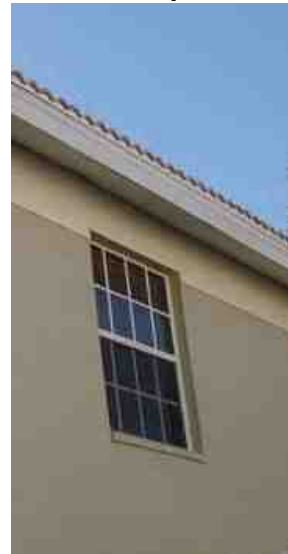
N	Opening Protection products that appear to be A or B but are not verified						
	Other protective coverings that cannot be identified as A, B, or C						
X	No Windborne Debris Protection	X			X	X

Unprotected Opening
